WILLIAMS LAKE DAM

MA. 00451

PHASE I INSPECTION REPORT
NATIONAL DAM INSPECTION PROGRAM

DECEMBER 1980

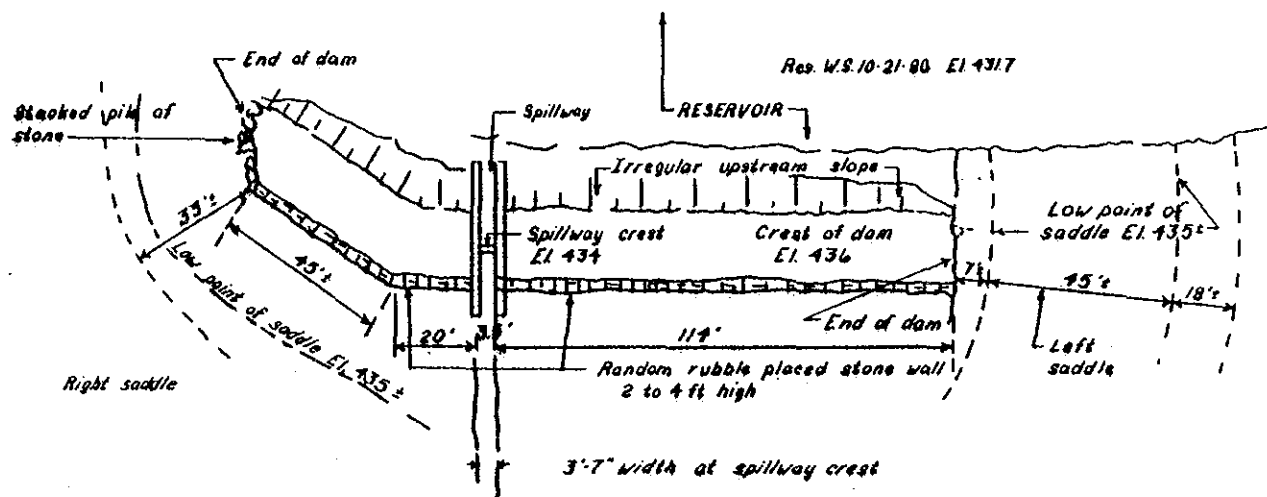
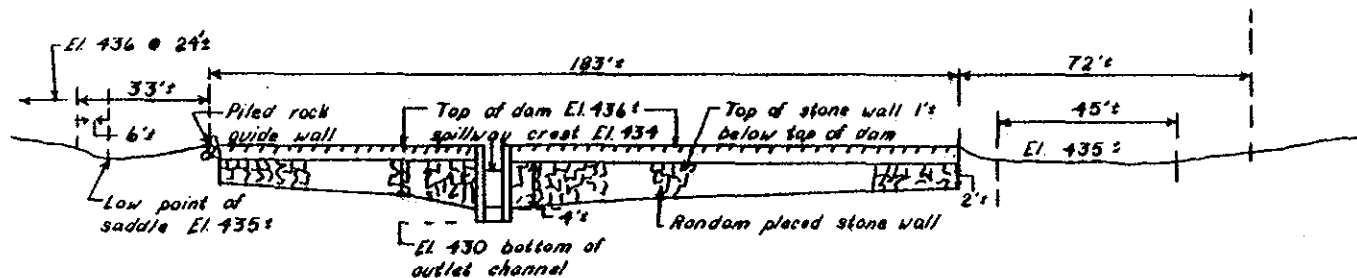
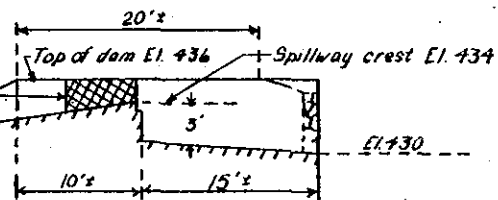
WILLIAMS LAKE DAM
MARLBOROUGH
PLAN AND PROFILES

Note: Right wall granite block displaced and lying in channel. Stone missing in left wall above crest level.

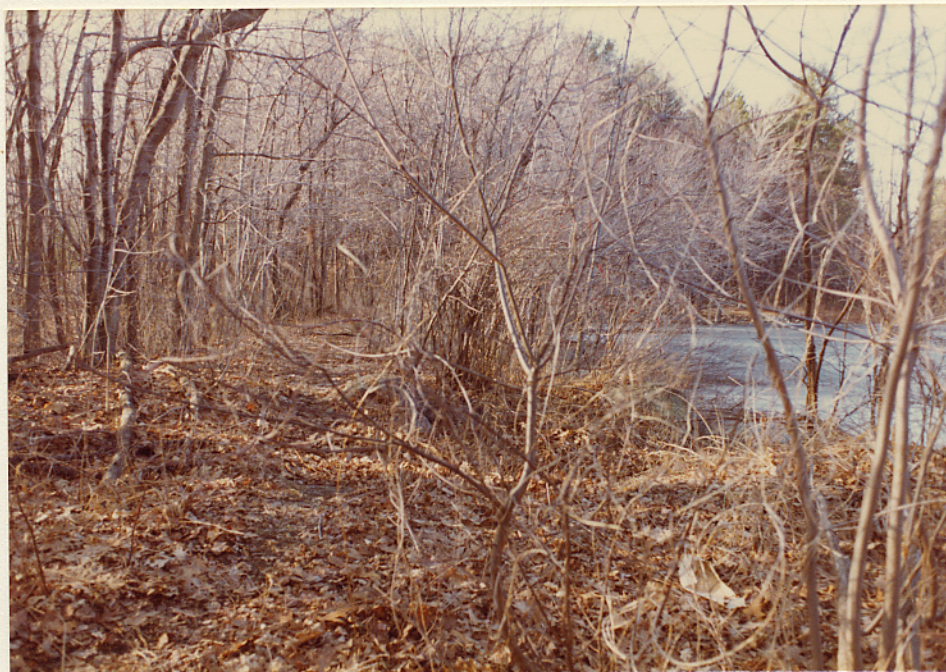
Abundant brush and tree growth extends along the entire length of the dam. (see Appendix C, Photo Nos. 1 & 2). The downstream stone wall is tilting in the downstream direction and a section of the wall has moved outward and is essentially demolished (see Appendix C, Photo Nos. 3 & 4). At the time of the inspection, there was no seepage observed along the downstream toe of the wall area. The upstream slope of the dam is irregular and overgrown with trees. The crest of the dam shows signs of trespassing as there is a footpath which passes along the entire length of the dam.

1. Brush and tree growth along crest of dam.

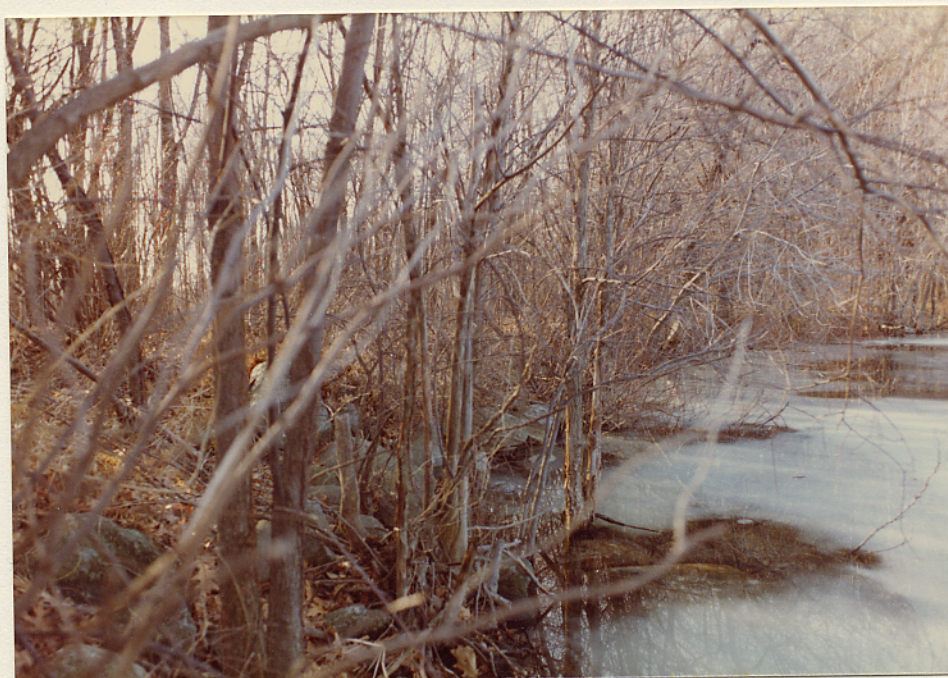
2. Brush and tree growth on upstream slope.

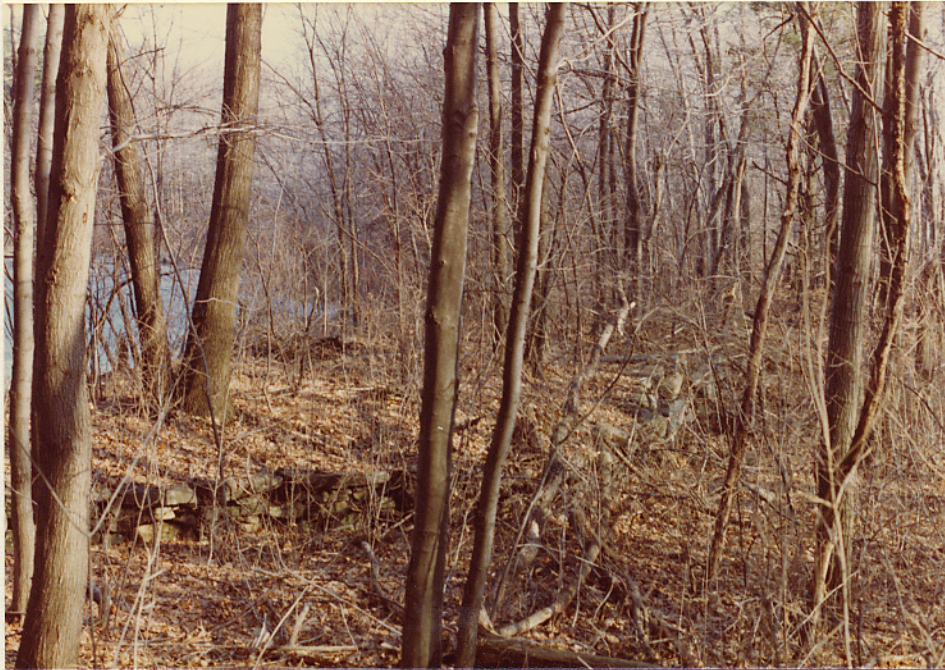
3. View of deteriorated downstream stone wall from right abutment.

(2) Repair the downstream rubble masonry walls.

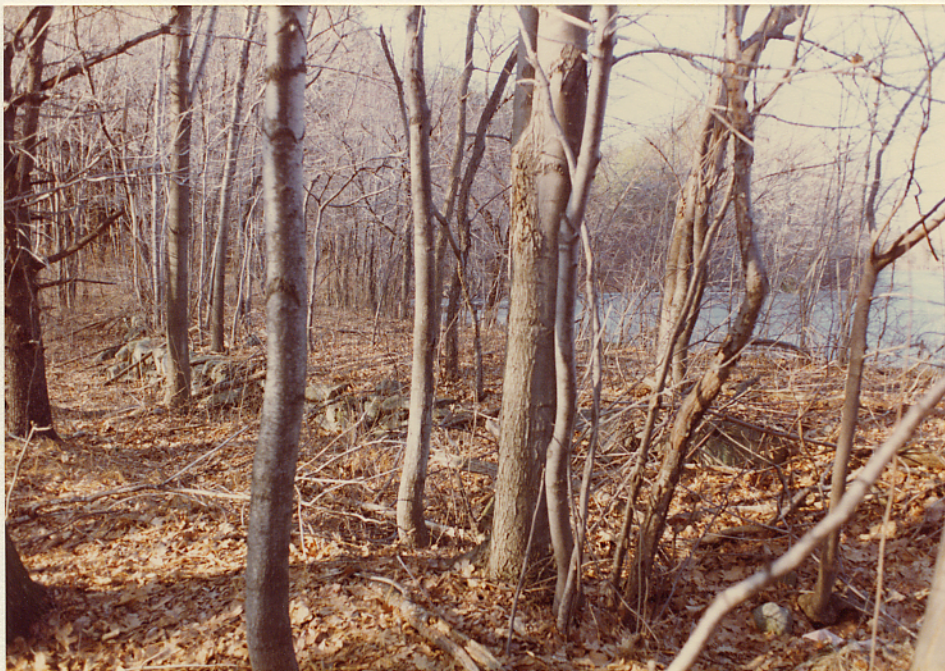
4. View of deteriorated downstream stone wall from left abutment.

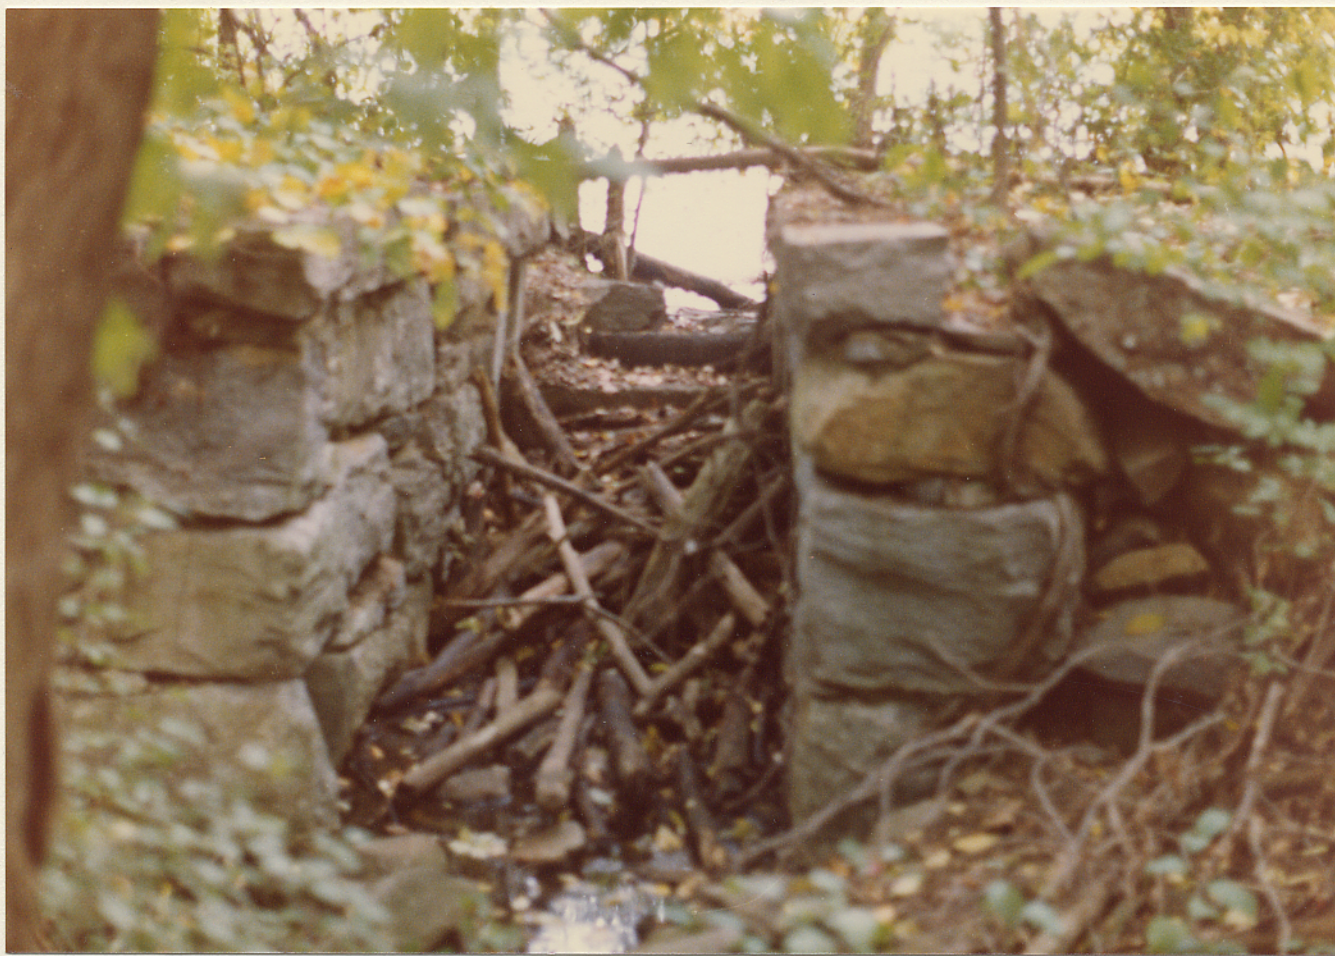
c. Appurtenant Structures. The spillway for the dam is located about 65 ft. left of the right abutment. It is of granite block construction and has a broadcrested wier which is 3.5 ft. long. The training walls are constructed of granite and extend 2 ft. above the spillway crest to the top of the embankment. The spillway is in poor condition, shows no sign of recent maintenance and is full of debris. A granite block has dislodged from the right spillway training wall and has fallen into the spillway channel. Debris has collected downstream of the weir (see Appendix C Photo No. 5). Though no seepage was noted downstream of the embankment area, a minor amount of clear seepage, estimated to be less than 1 gpm, was issuing through and beneath the spillway.

5. View of spillway from downstream toe of dam -
note: debris and deteriorated condition.

(1) Replace the dislodged stone in the spillway channel.
